## Adaptive Cruise Control Radar Test OEM Bumpers Coated With Protect CPPS

Report on the Radio Testing  
for  
Ngenco  
Limited  
on  
Processed Car Bumper Pieces  
Report no. TRA-049966-45-00A  
16 March 2020

REPORT ON THE RADIO TESTING OF A  
Ngenco Ltd  
Processed Car Bumper Pieces  
ABSORPTION CHARACTERISTICS ON 76 GHz CW SIGNAL

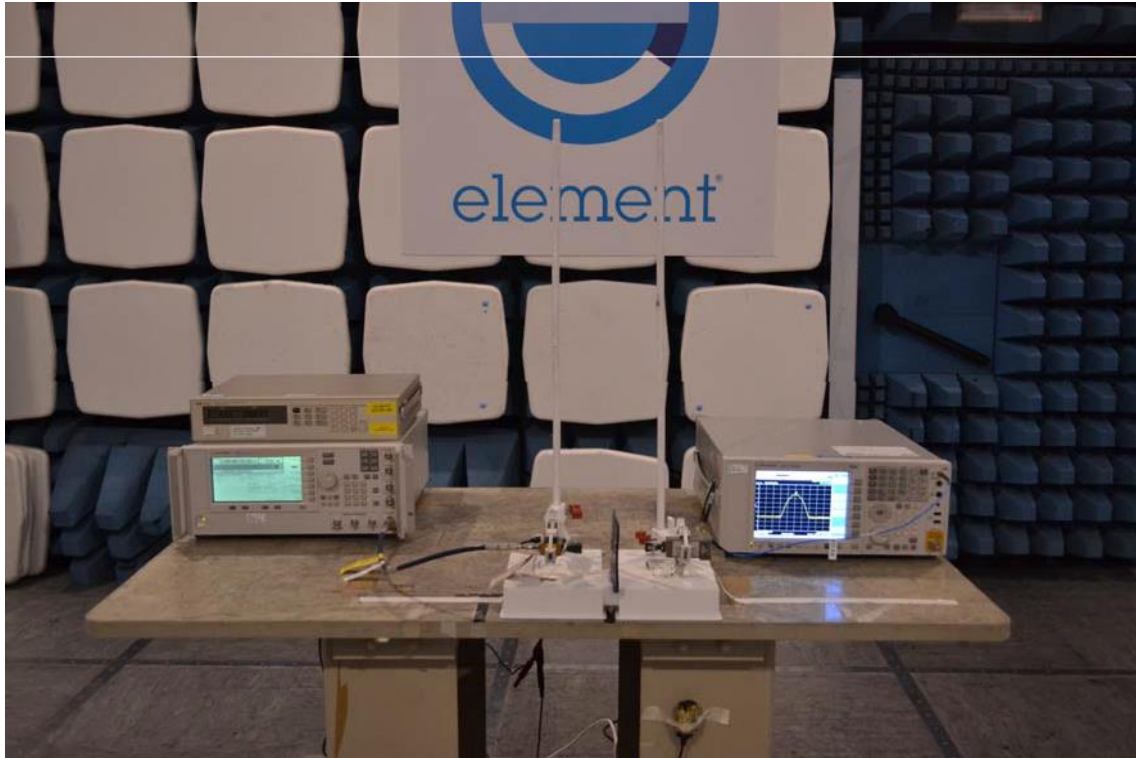
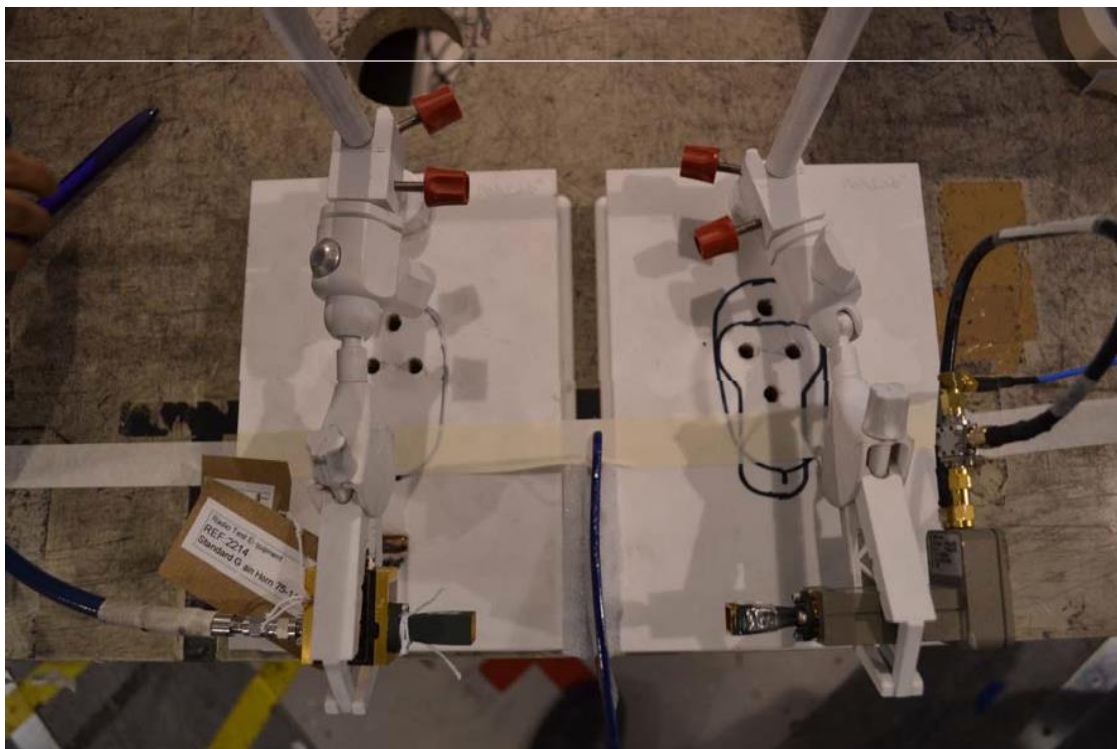
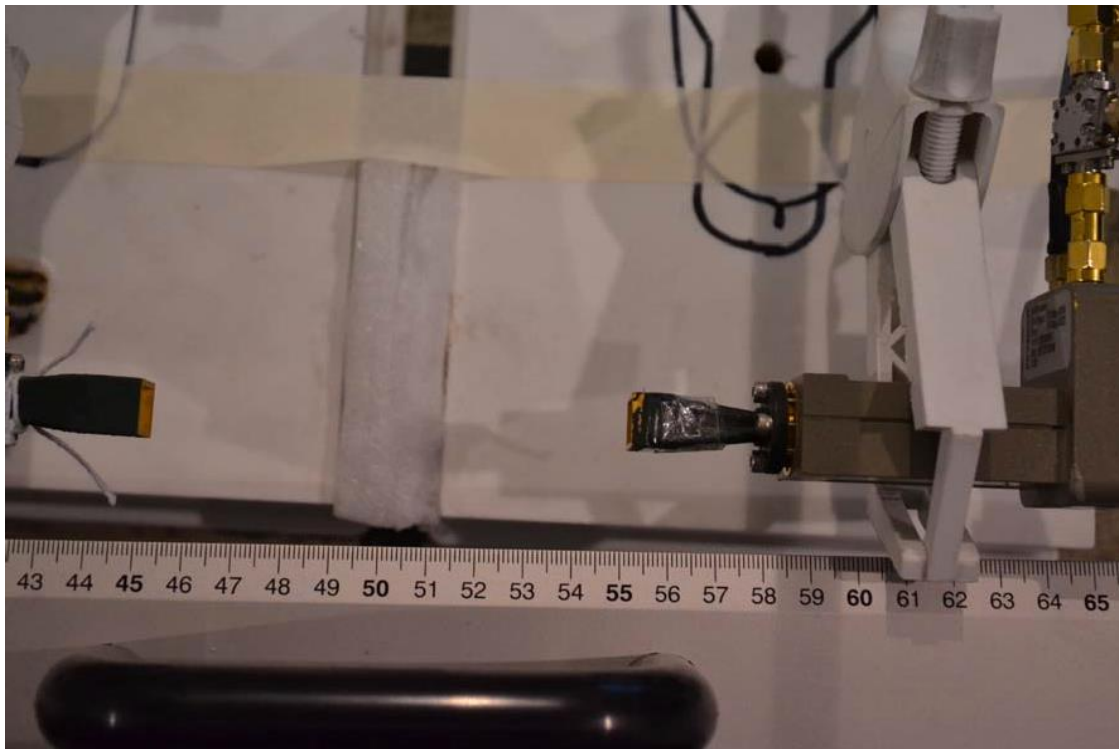
The following photographs shows basic EUT set-up:

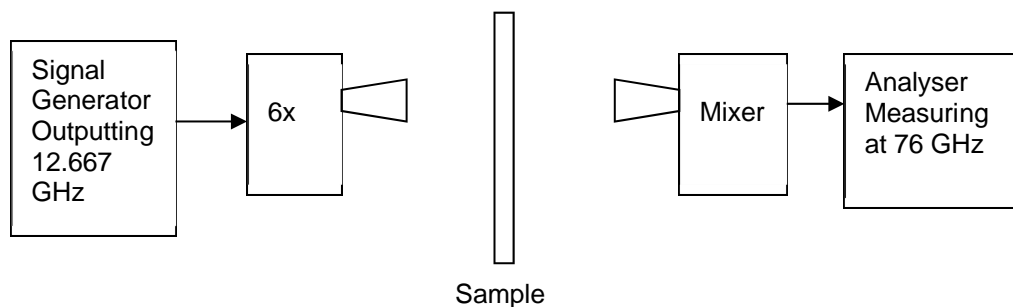
**Figure ix Test Setup**

With the EUT setup as per section 9 of this report and connected as per Figure ix, the testing of the level of attenuation of four bumper samples was performed.

1. A test bed was used, consisting of a 76 GHz CW transmitter and a tuned receiver to measure received signal strength in a controlled environment (semi-anechoic chamber), with space between the two antennas to insert the bumper samples. Separation between bumper sample and each antenna was  $\approx 50$  mm unless otherwise specified in writing.

2. The system was calibrated to give a known received signal strength at 76 GHz with no bumper sample present and this figure was recorded.

3. A bumper sample was inserted between the two antennas and the received signal strength was measured to obtain attenuation result.

4. The received signal strength at 76 GHz with no bumper sample present was measured again to ensure consistency and this figure was recorded.
